PROPERTY INSPECTION REPORT

By: [REDACTED] _____ **02/19/2014** _____
(Name and License Number of Inspector) (Date)

ADDITIONAL INFORMATION PROVIDED BY INSPECTOR

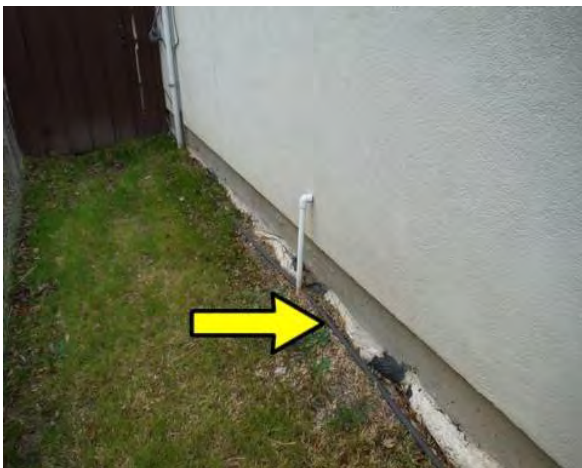
Fill dirt needed against the foundation beam on the west side, where the soil line is too low, to help support the foundation beam footing properly.

Foundation beam exposed on west side.

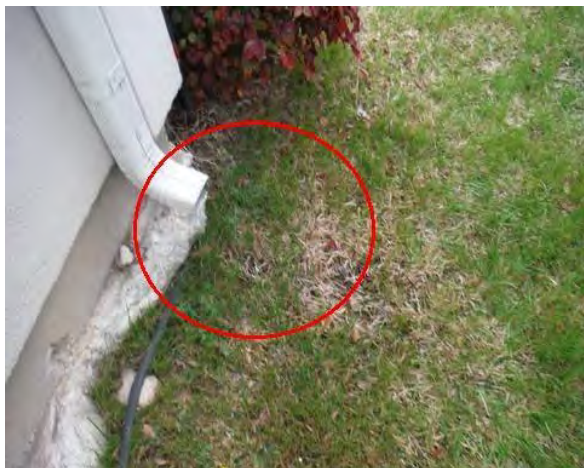
Splashblocks/diverters are needed at end of some downspouts to improve water flow.

Splashblocks missing.

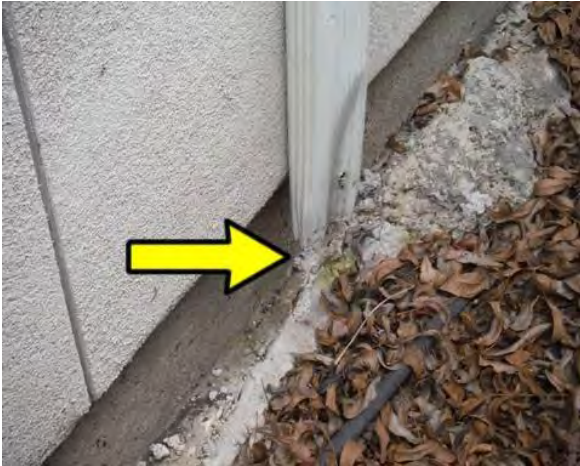
There is a west downspout that is missing the downspout leader at the bottom and is discharging at the foundation level. Recommend repair.

Downspout leader missing on west downspout.

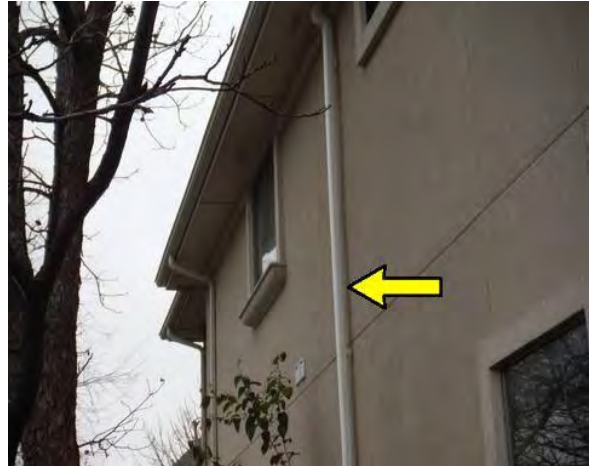
One of the west downspouts is not secured to wall. Recommend repair.

Downspout loose at wall on west side.

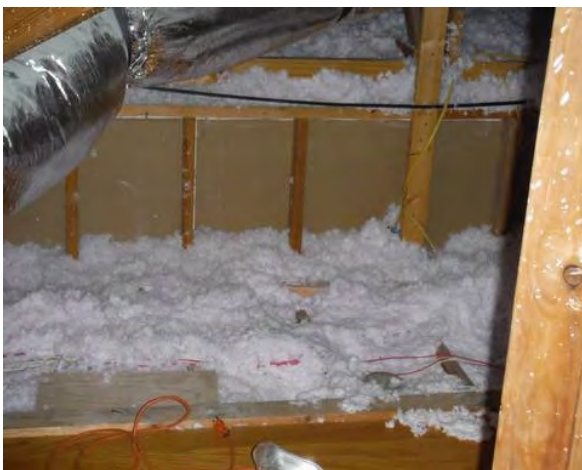
Batting insulation is missing on the south wall of the attic at the media room.

Missing batting insulation on south attic wall of media room.

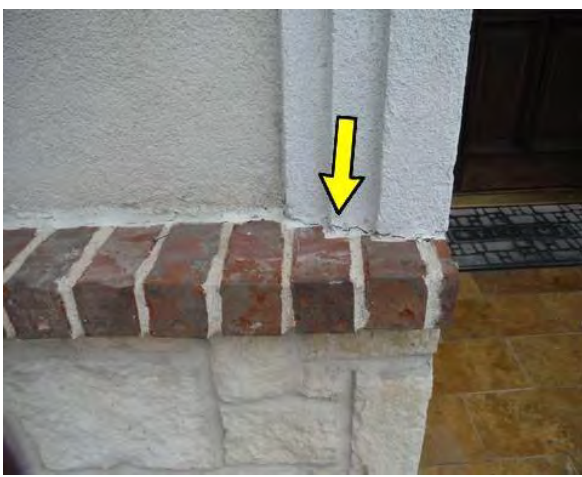
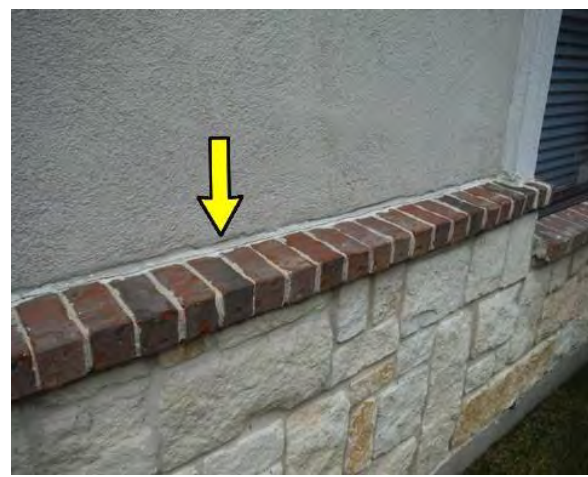
Reseal along the top of the brick corbeling where stucco meets as required to reduce potential moisture penetration.

Reseal along top of brick corbeling as required.

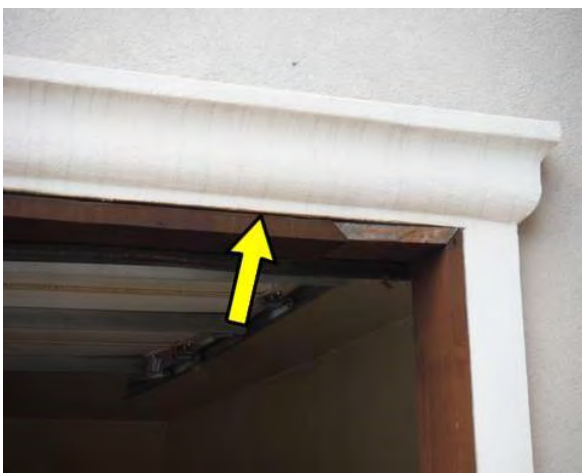
Reseal around garage door trim to reduce potential pest intrusion.

Reseal around garage door trim.

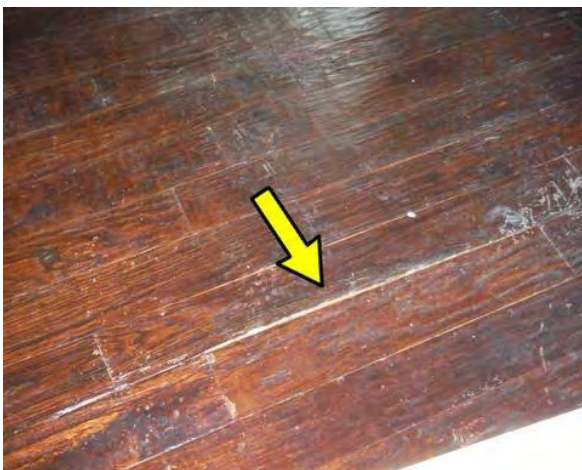
The foundation may have had movement beyond normal and/or moisture penetration due to tile cracks in the kitchen, laundry room and downstairs bathroom. Also, there is some wood floor buckling in the family room. Recommend evaluation by licensed structural engineer.

There was a diagonal crack across the kitchen tile floor, cracks in laundry room and downstairs bathroom. There was no indication of excessive movement/settling on the exterior. Also, there is some buckling of the wood floors in the family room. See "FOUNDATIONS" above for more information.

Wood buckling in family room.

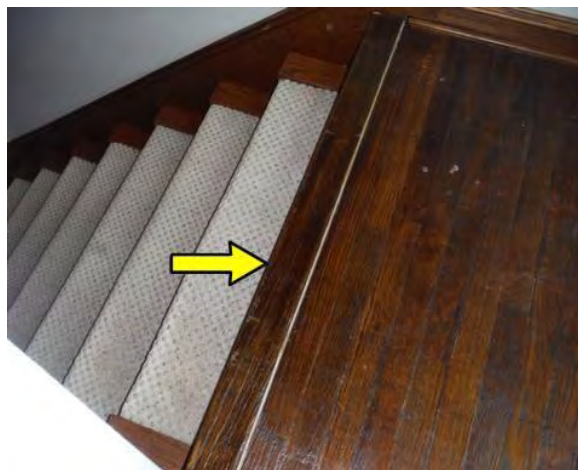
Top tread at landing is loose.

The edge of the top tread at the middle landing is loose and recommend repair to reduce tripping hazard.

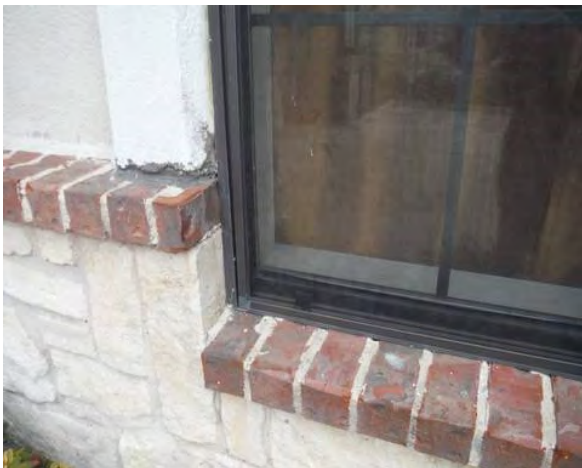
Recommend caulk and seal around windows as required to reduce possibility of leaking and moisture intrusion in home.

Reseal around windows as required.

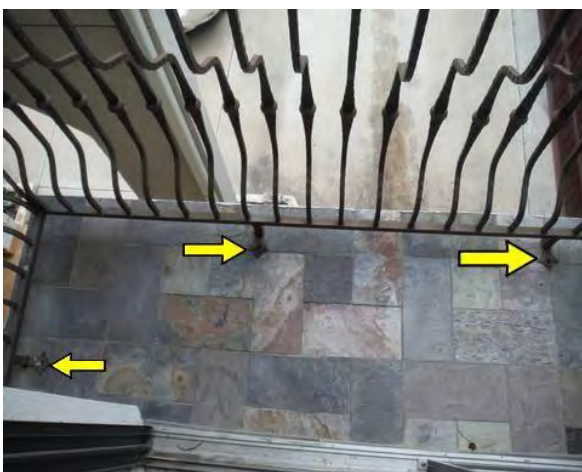
The bottom feet on the north balcony railing is not secured to base. Recommend repair to reduce potential safety hazard.

Missing fasteners at the balcony railing feet.

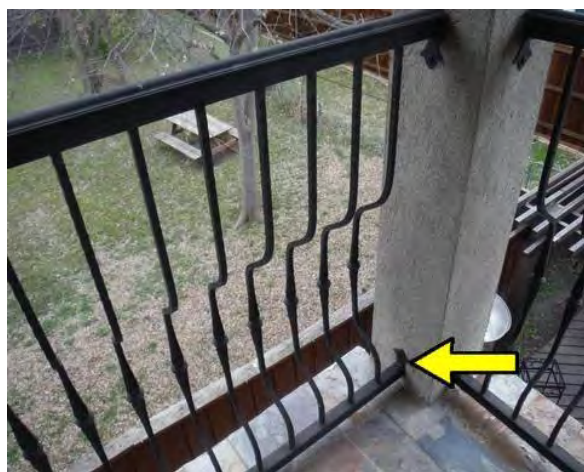
The west railing on the north balcony is loose. Recommend repair to reduce potential safety hazard.

West railing loose at north balcony.

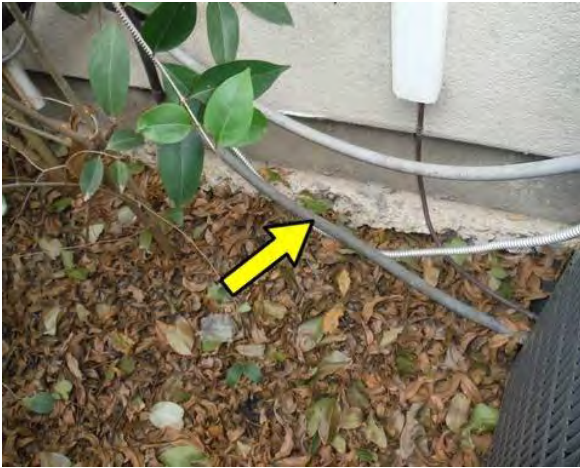
Refrigerant line to south condenser unit has missing insulation which should be repaired. Also, the conduit at the ac unit is loose and wiring is exposed. Recommend full evaluation and/or repair by licensed HVAC technician.

Insulation missing on refrigerant line.

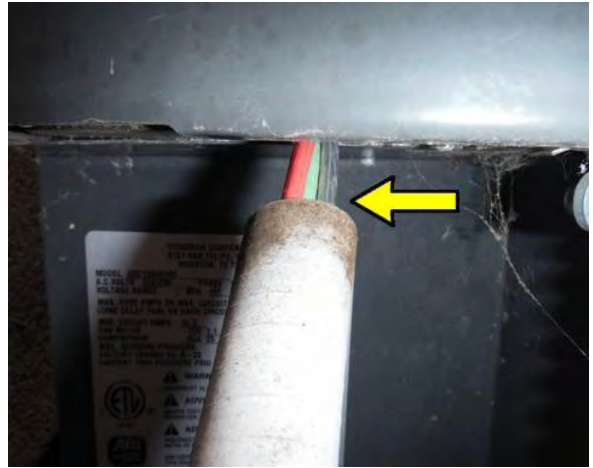
Conduit loose at south ac unit.

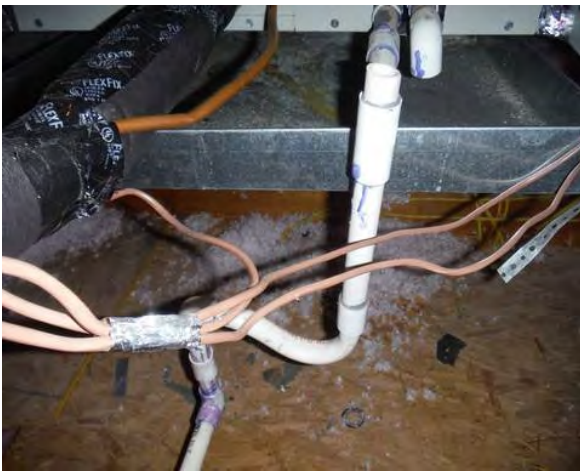
The vent on north attic unit is installed on the incorrect side of the p-trap on the main condensate drain line. Recommend capping existing vent and installing new vent on the opposite side of p-trap.

Vent is installed on incorrect side of p-trap on north unit. Cap existing vent and install new vent.

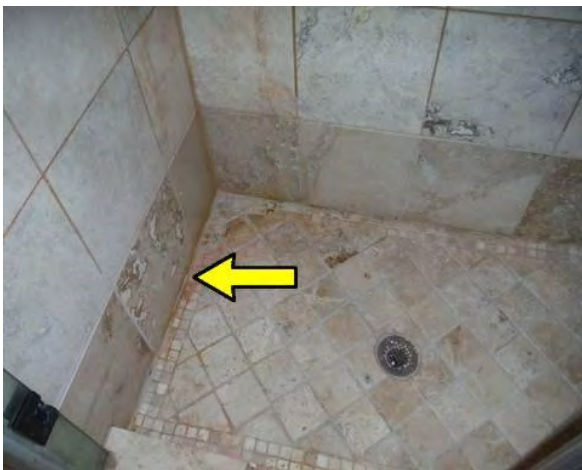
Reseal around the base and corners of the downstairs shower and master shower as required to reduce potential moisture penetration.

Reseal around base and corners of downstairs shower as required.

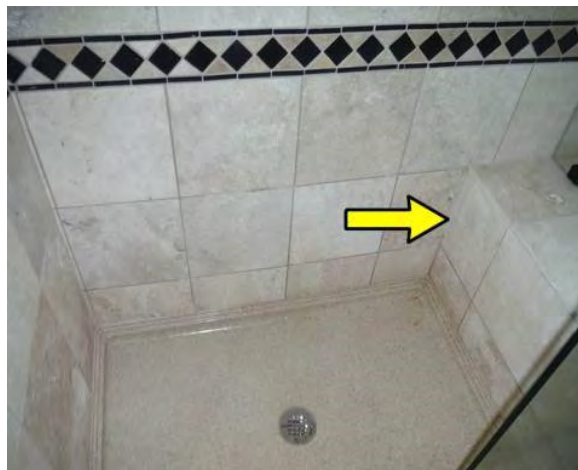
Reseal around base and corners as required in the master shower.

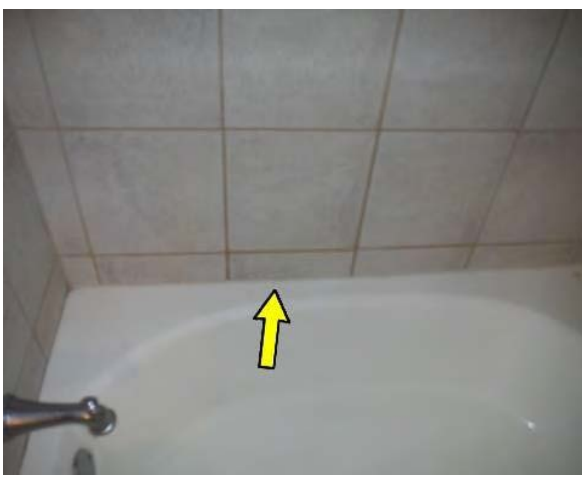
Reseal along top and corners of the tile surround above the upstairs tub as required to reduce potential moisture penetration.

Reseal along top and corners of upstairs tub.

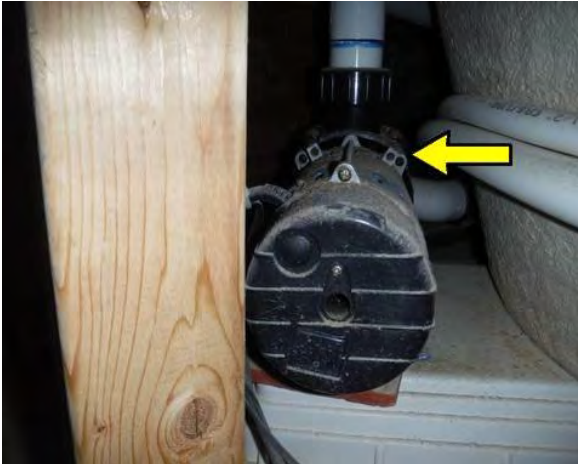
Comments:
Whirlpool appears to be supplied by a regular electrical source. This should be replaced with a GFCI receptacle/ breaker.
The pump does not appear to be bonded. Recommend evaluation by licensed plumber/electrician.

Missing bonding wire.
