PROPERTY INSPECTION REPORT

By: [REDACTED] _____ **02/19/2014** _____
(Name and License Number of Inspector) (Date)

ADDITIONAL INFORMATION PROVIDED BY INSPECTOR

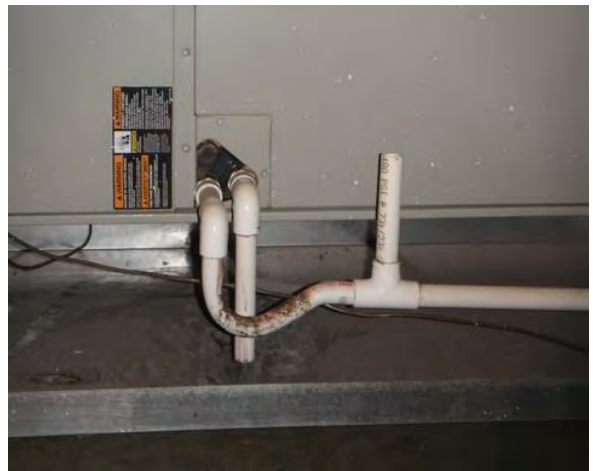
Vent is installed on incorrect side of p-trap on north unit. Cap existing vent and install new vent.

Example of correct installation of p-trap and vent on main condensate drain line.
